BUILDING 1017

CONDITION SURVEY

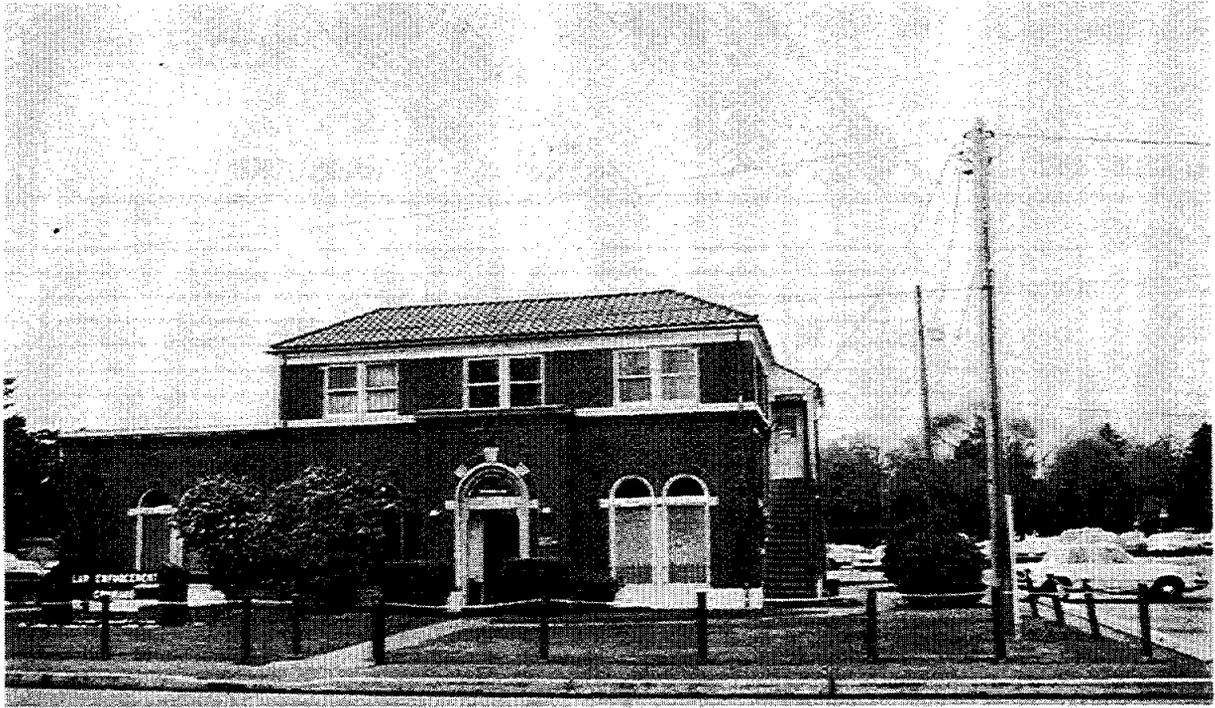
1987 PHOTO

1. Cracked glass in half-round transoms - east side and south side.
2. Poor pointing repair work at cornice of one-story wing.
3. Soil build-up and moss on masonry. Repointing needed, particularly in areas around downspouts. Major vertical crack through mortar joints on south side, full height of wall. Previous repair attempt has failed.
4. Two vertical cracks in foundation, south side.
5. Reflective film on windows is detrimental to the historic appearance of this building - remove visually intrusive, reflective film and replace with new non-reflective, low emissivity (Low E) film.
6. All windows are highly weathered and need to be reconditioned and refinished. Many panes of glass are broken and putty has fallen out.

1. **CRACKED GLASS**
 - a. Replace glass. See illustration of Glazing repair.
2. **REPOINTING AT CORNICE**
 - a. Clean off all excess mortar from previous repointing.
 - b. Rake out joints and repoint again, if necessary for an acceptable repair.
3. **REPOINTING - GENERAL**
 - a. Refer to article on "Brick Masonry Walls". Clean masonry and repoint accordingly.
 - b. Consult a preservation structural engineer for repair of major wall cracks.
4. **FOUNDATION CRACKS**
 - a. Consult a preservation structural engineer for analysis and repair of cracks.
5. **REFLECTIVE FILM**
 - a. Remove all reflective film applied to glass.
6. **WINDOWS**
 - a. Recondition windows according to procedures outlined in articles on "Wood Windows" and related illustrations.
 - b. Replace all broken glass.
