BUILDING 2014

CONDITION SURVEY

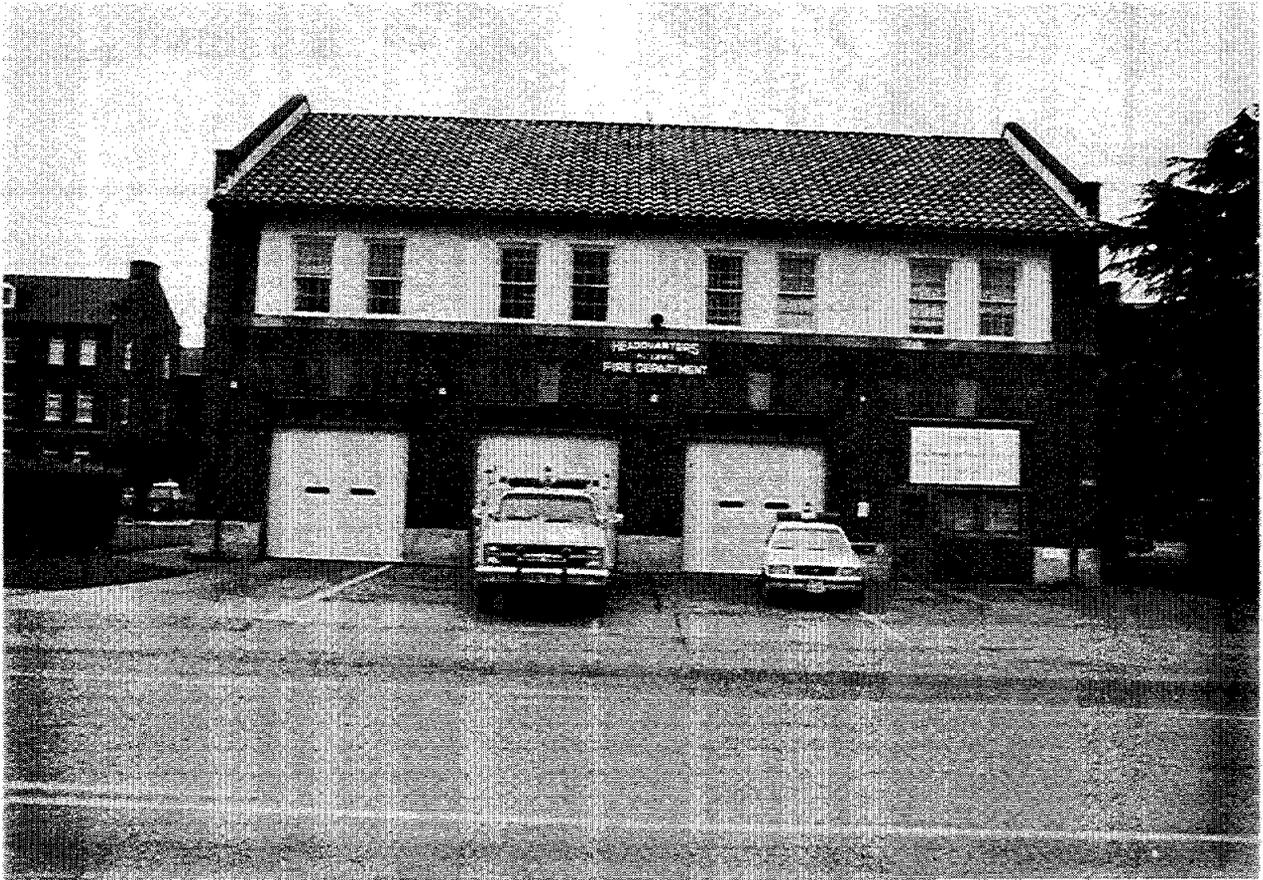
1987 PHOTO

1. Signage mounted flush on front of building detracts from the historic architecture of building.
2. Carbon dioxide tank and transformer on west side are visually intrusive.

3. Curb stops are needed for parking spaces abutting foundation.
4. Downspout sewer only on front side; appears plugged.
5. Vehicle damage to east downspout on front; ties broken.

6. Downspout ties corroded or broken on east side; extraneous attachment wire reacting with and staining downspouts. System is generally in good condition.

7. Mortar appears to be soft and deteriorating especially on the south end. Needs additional inspection and possible repointing.
8. Needs additional inspection of adequacy of attic ventilation system.

9. Roll-up main entry doors are out of keeping with historic character of building.
10. Use of window spaces for vents not in keeping with historic architecture. Fire extinguisher recharge system vent on south side particularly intrusive.

11. Steel window bars on second floor rear are corroding. Stubs from removed security bars on first floor rear are unsightly.
12. Sash putty is deteriorating severely on south side; need additional inspection of remaining sash.

13. Window sash and frame weathered; approximately 40% need immediate attention, particularly on east side.
14. Window frame trim piece missing, first floor west side.

15. Transom mullion desintegrating above door NW corner of west side. Door area was formerly a window; installation has been done sympathetically.
16. PVC vent pipe on east wall is unsightly; should be an internal run.

17. Sconce lighting over main doors not original and surface mount conduit is unsightly; western light has been removed and plugged. Replacement sconces should be globe-type similar to those adjacent to west side entry.

18. Security lighting has been mounted on faces of three sides of building.
19. Surface-mount wiring and extraneous or obsolete electrical and communications wiring present on building face.

20. Antennas are mounted on building faces.

1. **SIGNAGE ON BUILDING FACADE**
 - a. Develop an historic signage plan.
 - b. Remove signs as installed.
 - c. Relocate or install new signs on freestanding supports.

2. **VISUALLY INTRUSIVE EQUIPMENT**
 - a. Relocate away from entryways if possible.
 - b. Provide screening such as brick wall to reduce visual effect.
3. **PARKING AREAS**

- a. Provide pinned concrete parking bumpers at least 3 feet from building.
4. **PLUGGED DOWNSPOUT SEWER**
 - a. Clean sewer; refer to article on "Gutters and Downspouts".

- b. Evaluate need for sewerage or drywells on rear downspouts.
5. **DOWNSPOUT DAMAGE ON FRONT**
 - a. Rebuild downspout.
 - b. Reanchor original ties using new bolts in masonry.

6. **DOWNSPOUT TIES ON EAST SIDE**
 - a. Remove, clean, and repaint ties using anti-rust paint.
 - b. Reanchor original ties using new bolts in masonry and galvanic separators.

- c. Remove extraneous wire.
 - d. Replace wire ties with copper wire.
7. **DETERIORATING MORTAR**
 - a. Evaluate mortar condition and composition.
 - b. Repoint mortar joints.

- c. Refer to article on "Brick Masonry Walls".
8. **ATTIC VENTILATION**
 - a. Inspect attic space to evaluate ventilation system.
 - b. Install additional vents providing cross-flow system.

- c. New ventilation should not be easily visible.
9. **MODERN ROLL-UP DOORS**
 - a. Provide wood-panel leaf doors similar to originals (See original drawing File 2892) or provide metal rollup unit design used for historic industrial buildings on post.

10. **VENTS AND EQUIPMENT IN SASH WINDOWS**
 - a. Install vents through masonry.
 - b. Install new sash to match original.
11. **CORRODING WINDOW BARS**
 - a. Strip paint, scrape and wire brush.

- b. Remove severe rust with naval jelly.
 - c. Prime and paint with rust-inhibiting enamel.

12. **DETERIORATING SASH PUTTY**
 - a. Chip out bad putty and scrape surface clean.
 - b. Check for adequate glazing points.
 - c. Brush wood with linseed oil.
 - d. Refer to article on "Wood Windows".

13. **WEATHERED SASH PAINT**
 - a. Scrape, fill, and sand.
 - b. Replace window putty where loose or missing.
 - c. Refer to articles on "Wood Windows" and "Paint".

14. **MISSING WINDOW TRIM**
 - a. Install new trim matching original dimensions and shape.

15. **DETERIORATING TRANSOM MULLION**
 - a. Remove transom and disassemble in shop.
 - b. Mill new mullion(s) to match original.
 - c. Reassemble and reinstall.
 - d. Prime and paint.

16. **PVC VENT PIPE**
 - a. Remove and reinstall using internal run.

17. **FRONT ENTRY LIGHTS**
 - a. Remove lights and surface-mount wiring.
 - b. Install new lights similar to those on west entry.
 - c. Use internal wiring runs.

18. **SURFACE-MOUNT LIGHTING**
 - a. Relocate security lighting to freestanding poles.
 - b. Patch holes in brick.

19. **OBSOLETE AND SURFACE-MOUNT WIRING**
 - a. Remove obsolete wiring.
 - b. Provide interior runs for active wiring.

20. **ANTENNAS ON BUILDING**
 - a. Relocate antennas to attic or freestanding area.
 - b. Small military communications antennas may be mounted to rear of building.
