BUILDING 2027

CONDITION SURVEY DATA SHEET

CONDITION SURVEY

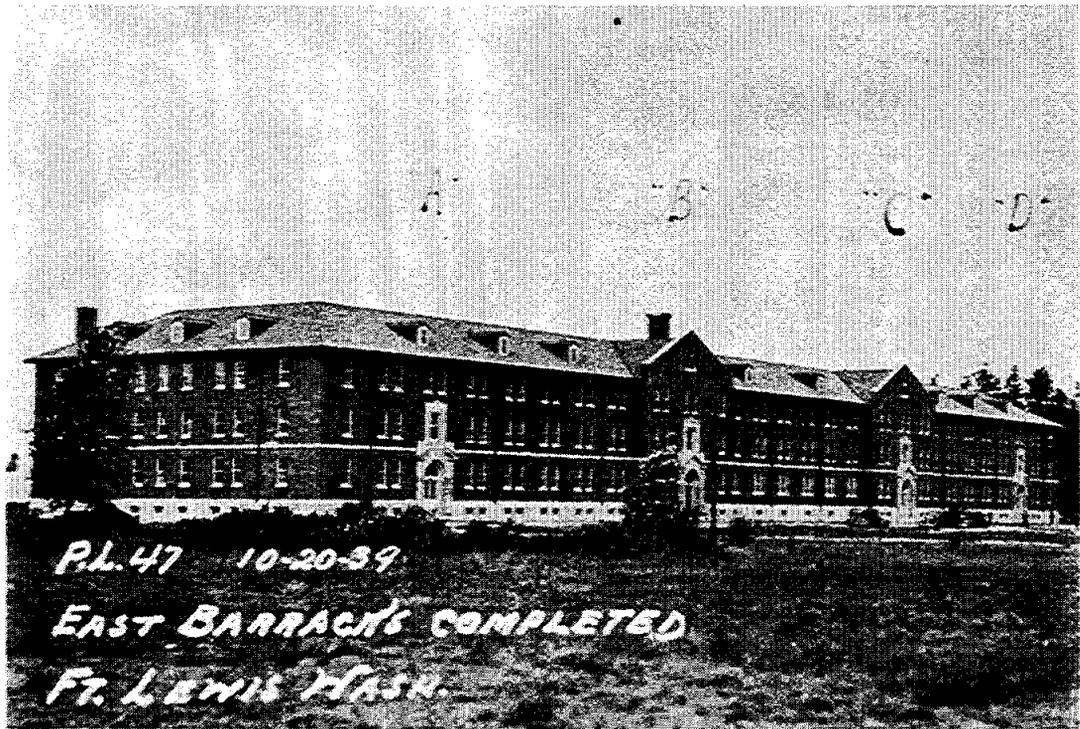
Building 2027 (formerly 602) was built in 1939 as a barracks and now serves as headquarters for the 9th Infantry Division. The three story building is based on standardized Office of Quartermaster General plans with intersecting hipped tile roofs and four rear wings. Although based on and related to the earlier Colonial Revival style seen on post, the building includes an atypical arched and colonnaded brick rear porchway and simplified interior details more related to the Moderne style. Four main entries include decorative stone door surround, with the central two located on protruding gabled pavilions with fan windows. The concrete post-and-slab structural system supports an infill hollow tile and brick wall system.

Building character is established by its overall symmetry, the rhythm of the 6/6 sash windows, the decorative stonework, and the monumental rear porches. Minor but important details include fan windows, decorative wrought-iron railings, and ornamental cast-iron downspout boots and copper gutter system.

The building has not been severely modified with the exception of unsightly cable runs on the interior and air conditioning ducting on the exterior.
