BUILDING 2043 - 44

CONDITION SURVEY

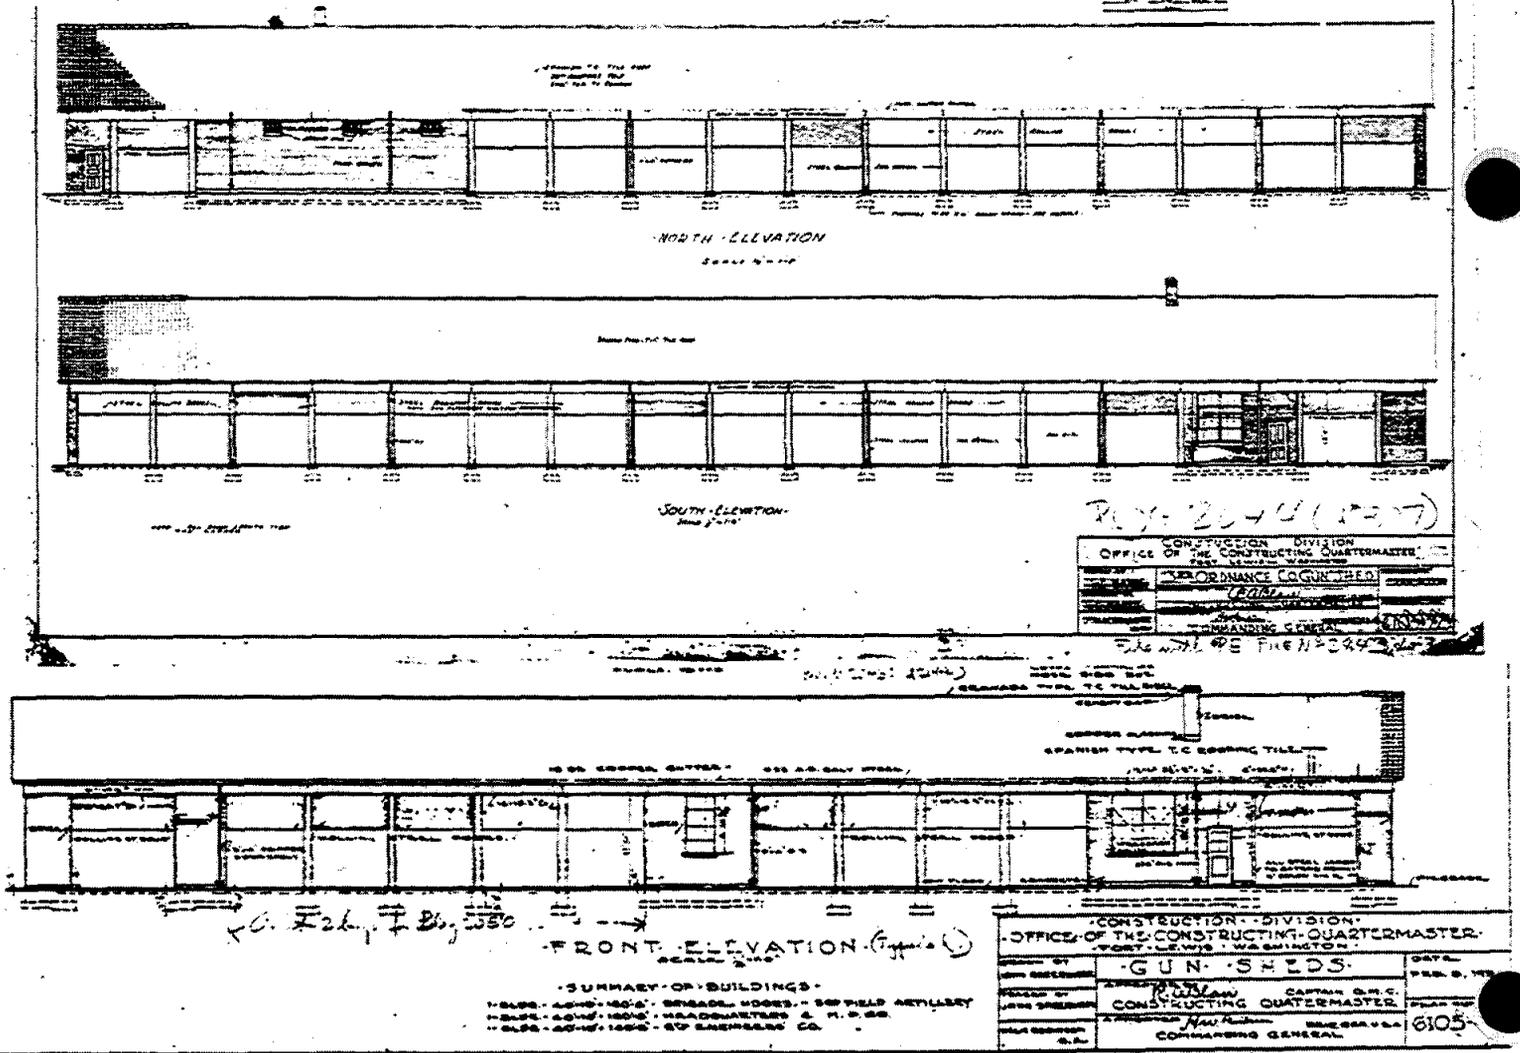
Building 2043 - 44 (formerly 306 - 307) consists of two masonry shop buildings connected with a frame infill building. The original buildings have tile roofs, the infill has composition shingles in poor condition.

Most of the man doors have been replaced and many of the vehicle doors have been infilled with plywood.

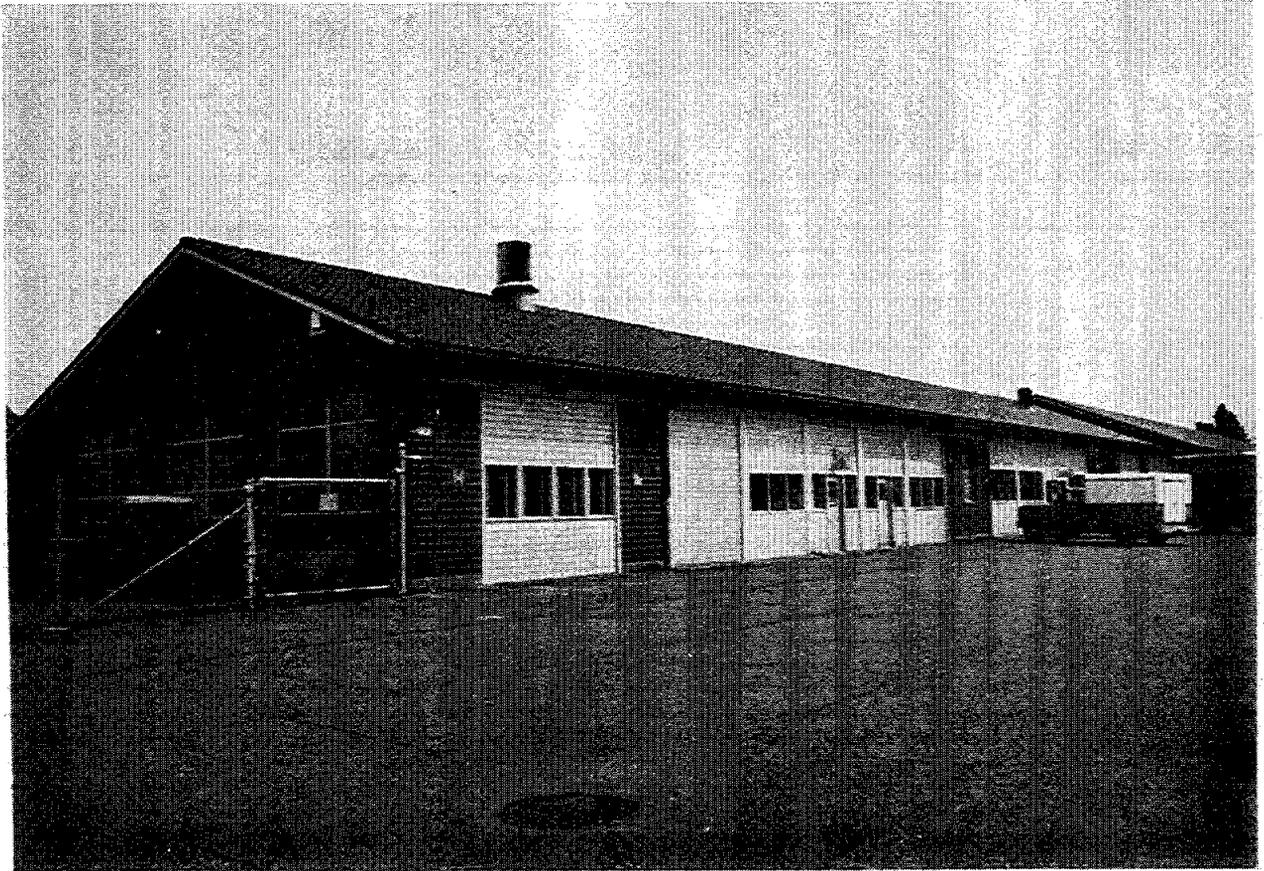
1987 PHOTO

1. Masonry ties are rusting.
2. Moss is present on window sills.
3. Moss is present at foundation.
4. Composition roof at infill is mossy.
5. Paint on siding is loose.
6. Glazing stops at doors are loose.
7. T 1-11 siding is out of character.
8. Replacement flush door is delaminating.
9. Roof ventilators are rusting.
10. Exterior doors are worn.

1. **MASONRY TIES**
 - a. Remove rust with wire brush.
 - b. Prime and paint.
2. **MOSS ON SILLS**
 - a. Remove with natural bristle brush and bleach solution.

- b. Rinse and dry.
3. **MOSS AT FOUNDATION**
 - a. Remove with spatula and bristle brush.
 - b. Spray with garden hose.
4. **MOSS ON ROOF**
 - a. This is often an indication that roofing is nearing the end of its life.

- b. Refer to Roofing Study prepared concurrently.
5. **PAINT**
 - a. Scrape and sand to remove loose paint.
 - b. Prime and paint.
6. **LOOSE GLAZING STOPS**

- a. Remove stops.
 - b. Remove soil and debris.
 - c. Reinstall glazing stops. Replace if soft, weak, or warped.
7. **T 1-11 SIDING**
 - a. As budget permits, replace with horizontal siding characteristic of the period.

- b. Since plywood siding may not last as long as horizontal siding, its eventual replacement must be budgeted for.
8. **FLUSH DOORS**
 - a. Replace with panel door type 53.

9. **RUSTING VENTILATORS**
 - a. Sand to remove all rust.
 - b. Prime and paint.
10. **DOORS**
 - a. Clean thoroughly.
 - b. Replace loose glazing stops.
 - c. Patch or fill voids.

- d. Sand and paint with semi-gloss exterior paint.
