BUILDING 2049

CONDITION SURVEY DATA SHEET

CONDITION SURVEY

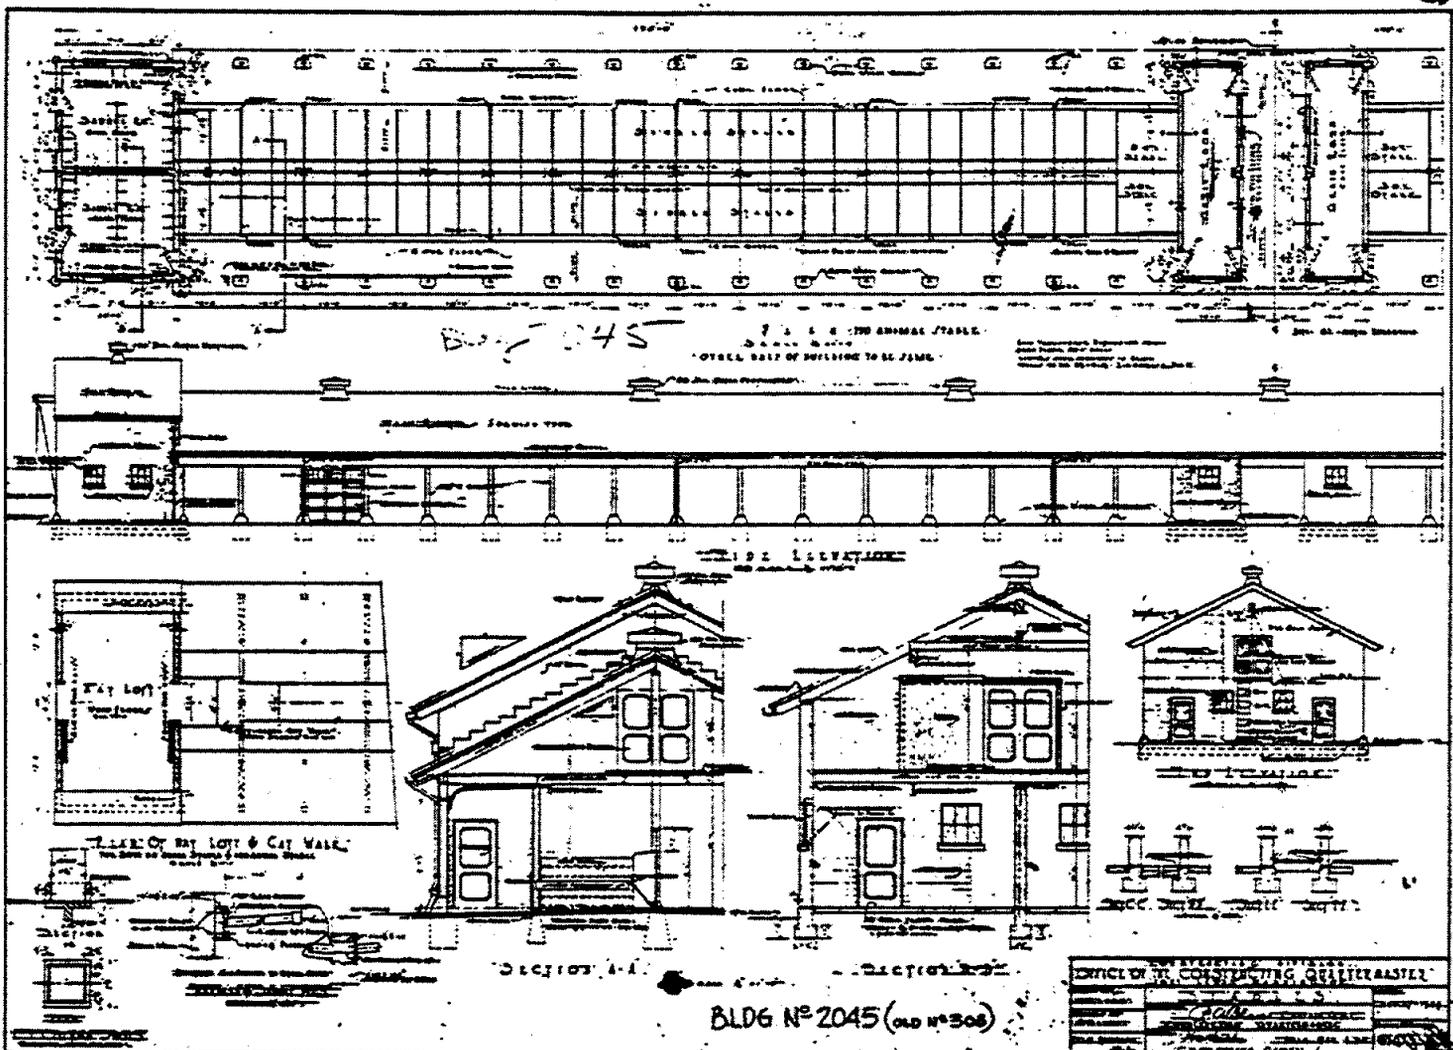
Building 2049 (formerly 310) is a masonry shop building constructed in 1934 as a stable. It is a shorter version of 2045, with a hay loft and saddle room at the east side. Many of the original doors remain but need immediate paint protection.
