BUILDING 2050

CONDITION SURVEY

SHOP

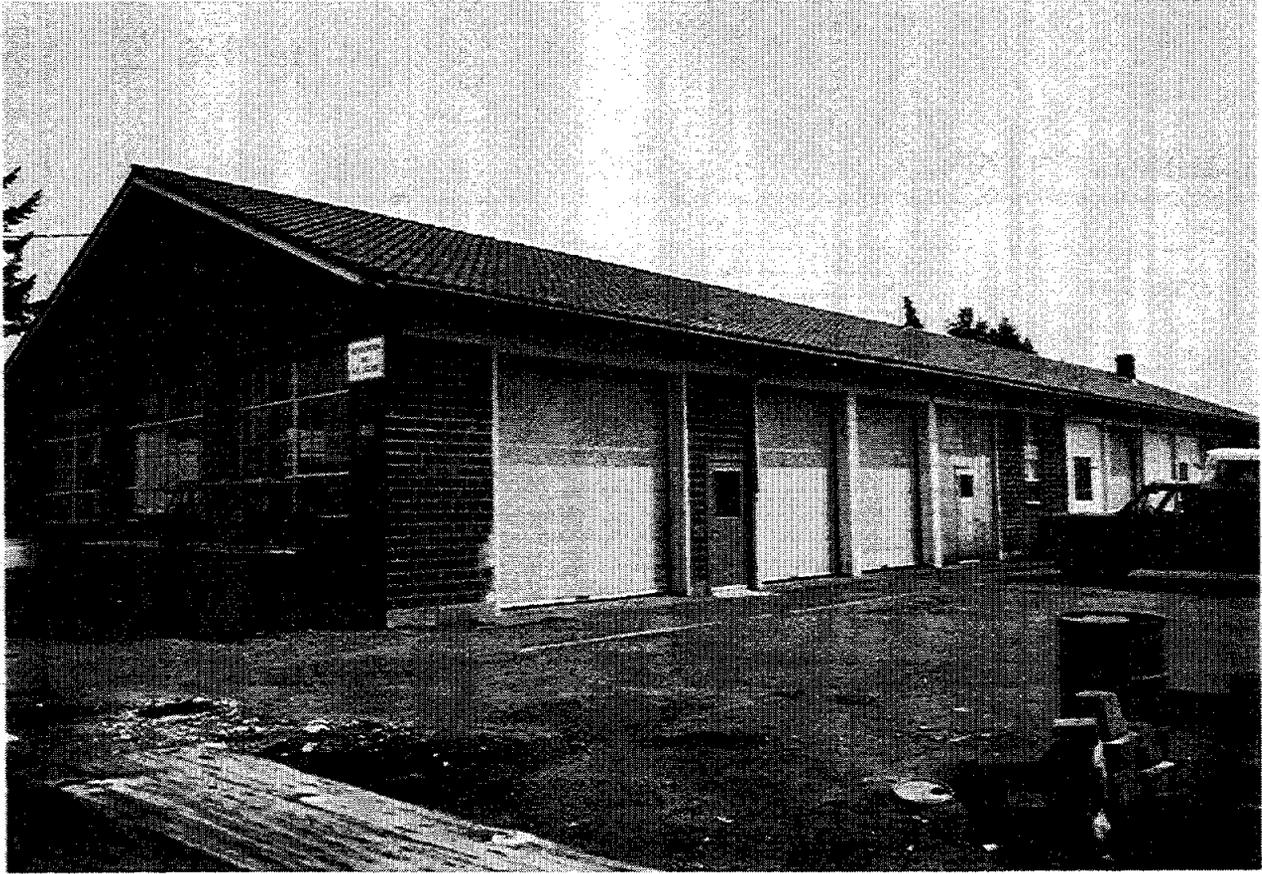
1987 PHOTO

1. Birds are entering soffit.
2. T 1-11 infill panels are not appropriate to character of building.
3. Aluminum sliding windows are not appropriate to character of building.
4. Metal sashes are rusting.
5. Caulk at sashes is hardening.
6. Moss is present on window sills.
7. Pounded water is present at man doors.
8. Masonry is soiled with mud at north side.
9. Site does not drain well.
10. Tile is missing at east gable end.
11. Shed roof leaks, rafter ends are splitting and weak, decking is rotting, gravel stop is loose, birds are nesting at column bracing and at junction with building.

1. **BIRDS**
 - a. Close or screen openings.
 - b. Remove bird droppings from face of building.
2. **T 1-11 PANELS**
 - a. As budget permits, replace with horizontal siding characteristic of the period.

- b. Since plywood siding may not last as long as horizontal siding, its eventual replacement must be budgeted for.
3. **ALUMINUM WINDOWS**
 - a. Replace with wood sash windows.

4. **RUSTING SASHES**
 - a. Remove all rust with wire brush, sanding and steel wool.
 - b. Protect glass.
 - c. Prime immediately.
 - d. Replace loose, missing or cracked glazing putty.

- e. Paint with oil based semi-gloss paint.
 - f. Oil hardware.
5. **CAULK AT SASH**
 - a. Remove hardened, brittle caulk.
 - b. Replace with new resilient caulk all around.

6. **MOSS ON SILLS**
 - a. Remove with natural bristle brush and bleach solution.
 - b. Rinse and dry.
7. **PONDED WATER**
 - a. Repave to slope toward existing drains.

8. **SOILED MASONRY**
 - a. Scrub with natural bristle brush and spray from garden hose.
 - b. Clean periodically to keep masonry free of material which holds moisture.

9. **SITE DRAINAGE**
 - a. Regrade to drain away from building and work areas.
10. **GABLE END TILE**
 - a. Replace with tile matching existing in appearance and quality.

11. **SHED**
 - a. It is probably time to rebuild this shed.
 - b. Follow similar timber framing and bracing details.
