## NCO HOUSING TYPE 2 B

**BUILDINGS 5002, 5004, 5009, 5011, 5013**

# CONDITION SURVEY DATA SHEET

## CONDITION SURVEY

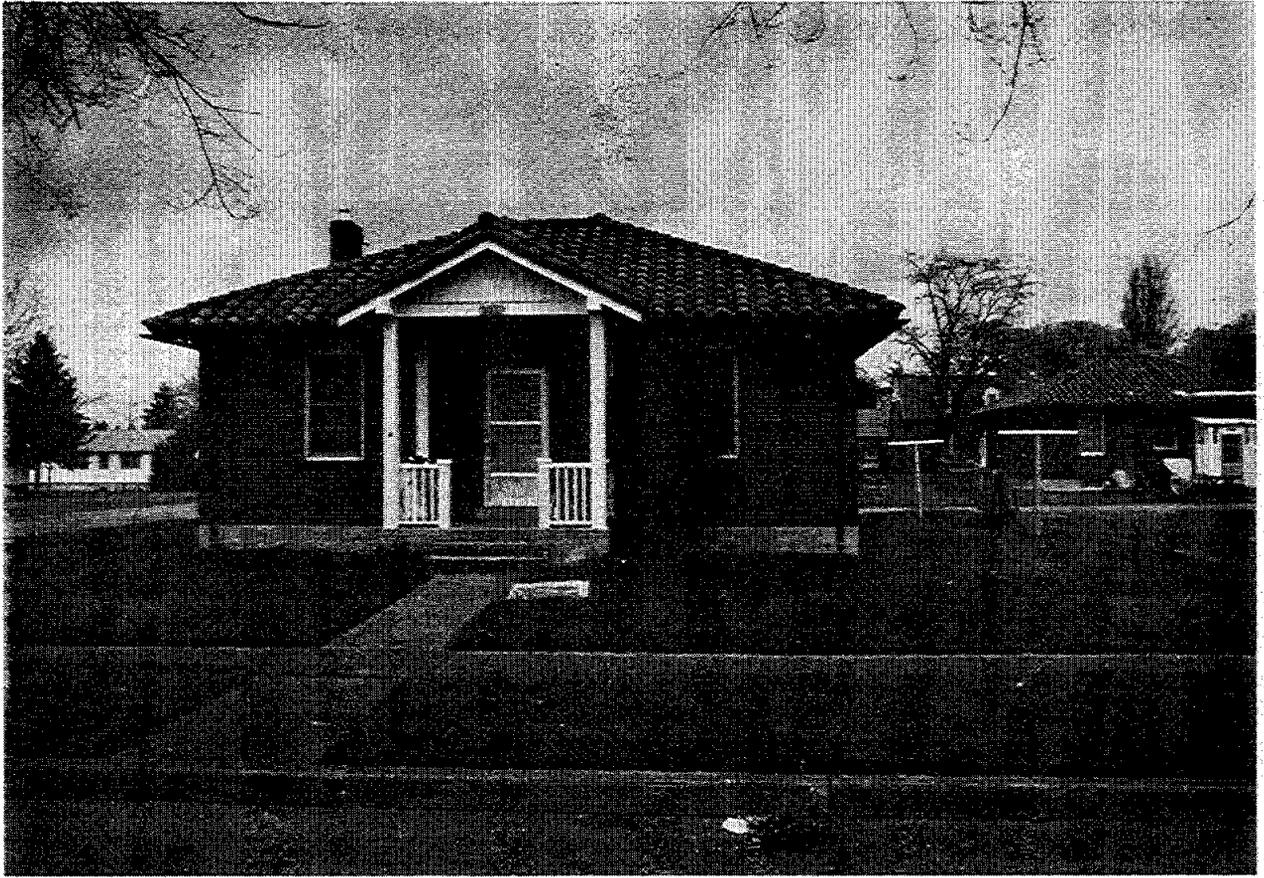
1987 PHOTO

1. Adequate attic cross ventilation needs to be verified.
2. Wood sashes are weathering. Some glazing putty is cracked, loose or missing allowing water penetration.
3. Sod build-up has prevented water from draining away from buildings.
4. Ridge tile is missing from Building 5002.
5. Entry shrubbery is harshly topped.

- a. Provide cross ventilation equal to 1/150 of roof area.
- b. Flash watertight.

- a. Scrape, and sand to remove loose paint.
- b. Fill voids and sand.
- c. Reglue loose joints.
- d. Clean and wax jambs.
- e. Replace all loose and cracked glazing putty.
- f. Paint.

- a. As budget permits, regrade to allow water to flow away from building.
- b. Re-sod.

- a. Replace with material matching existing in appearance and quality.

- a. Remove overgrown shrubbery.
