OFFICER'S HOUSING TYPE 1A

CONDITION SURVEY DATA SHEET

OFFICER'S HOUSING TYPE 1 A

CONDITION SURVEY

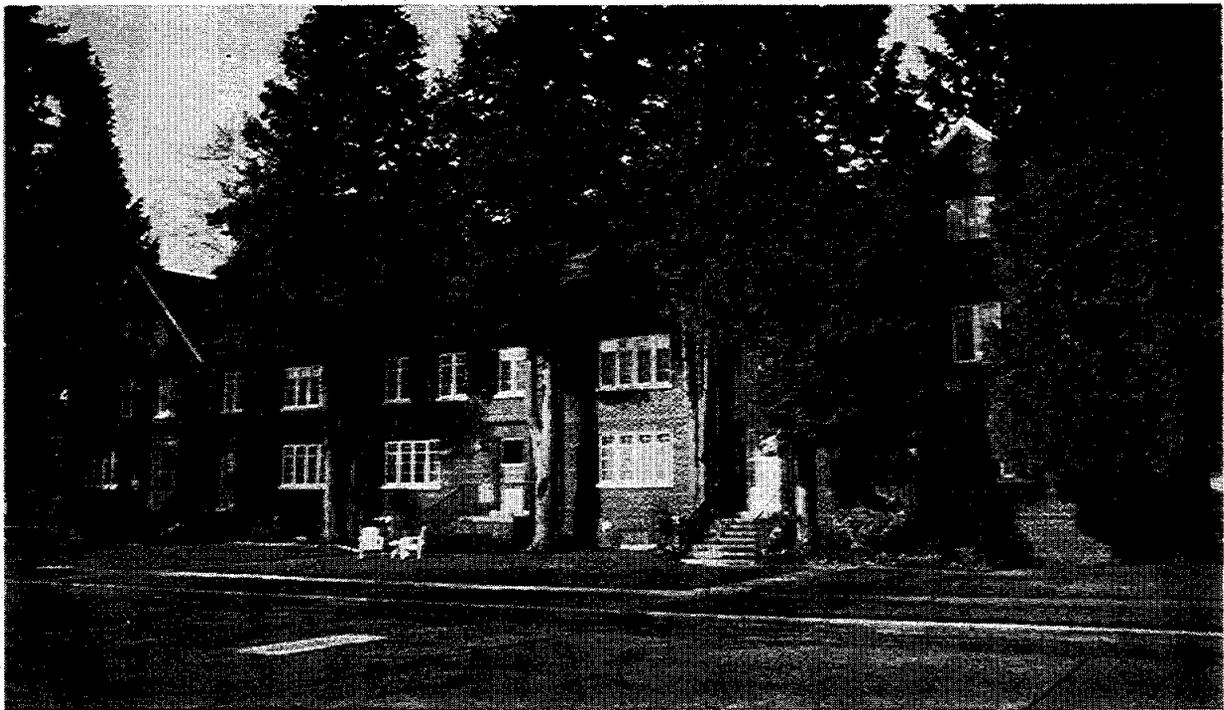
1987 PHOTO

1. Many large trees are tight against walls causing build-up of needles and debris on roofs. This will clog gutters and downspouts.
2. Moss and soiling on lower portions of walls, and also where trees are too close.
3. Side wall shingles of dormer vents are deteriorated. Loose flashing is falling out.
4. Old ivy tendrils are still attached to brick. Leaking hose bib is staining brick.
5. Porch steps: Soiled, moss growth, spalling, and broken corners, grass growing in crevices.

- a. Remove trees that are within 6 feet of face of building.
- b. Clean all needles and debris off roof.
- c. Clean out all gutters and downspouts.

- a. Refer to article on "Brick Masonry Walls".
- b. Using stiff natural bristle brush, scrub off soil build-up and moss.

- a. Replace rotted or split shingles.
- b. Prime and paint.
- c. Resecure loose flashing.

- a. Clean ivy tendrils off brick with stiff natural bristle brush.
- b. Repair leaking hose bibs.
- c. Clean water stains from masonry.

- a. Refer to article on "Concrete".
- b. Clean off moss, dirt and grass.
- c. Patch spalled and broken concrete according to related articles.
