OFFICER'S HOUSING TYPE 1-C

CONDITION SURVEY DATA SHEET

CONDITION SURVEY

FOUR FAMILY APARTMENTS

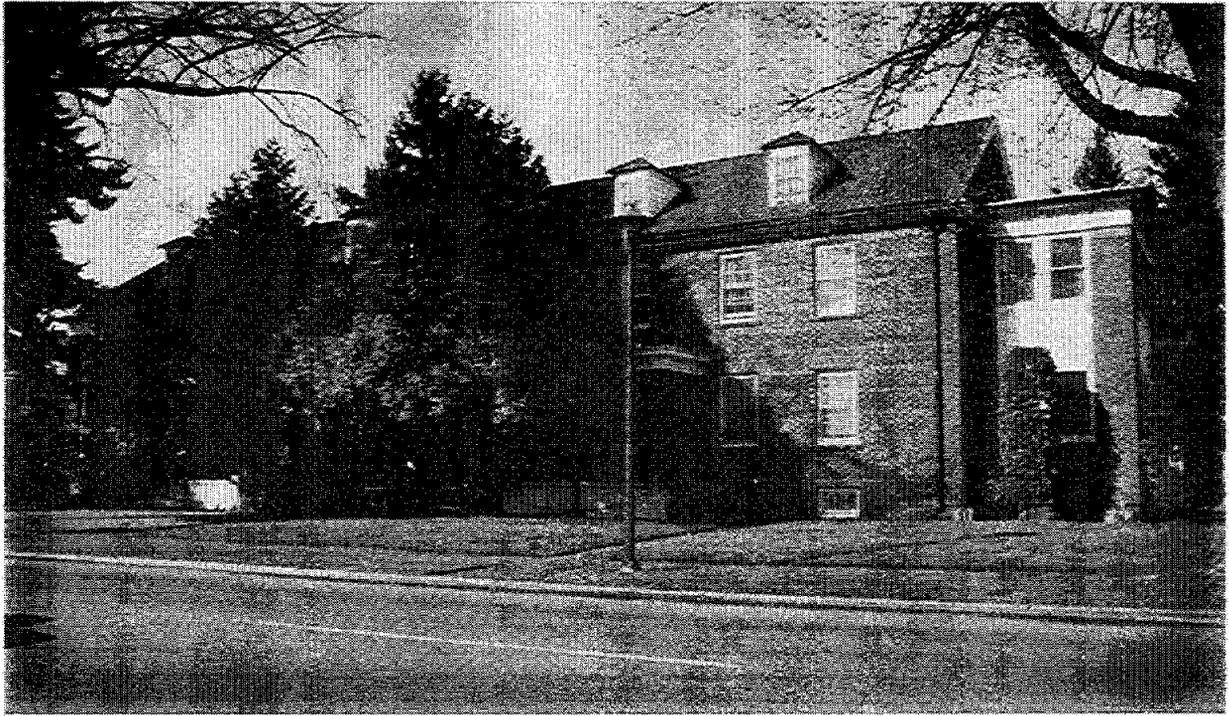
1987 PHOTO

These buildings were constructed in 1934 as four-family apartments. They are two story brick structures on reinforced concrete foundations with a simple gable roof and flat roofed extension wings at each end. The original flat tile roofing has been replaced with a spanish style tile. The original 6/6 double hung windows, in the end extension wings only, have been replaced with vinyl 1/1 double hung units of slightly different proportions. Roof balustrades originally adorned each of the two double entry porch roofs but they no longer exist.
