## BUILDING 4076

# CONDITION SURVEY DATA SHEET

## CONDITION SURVEY

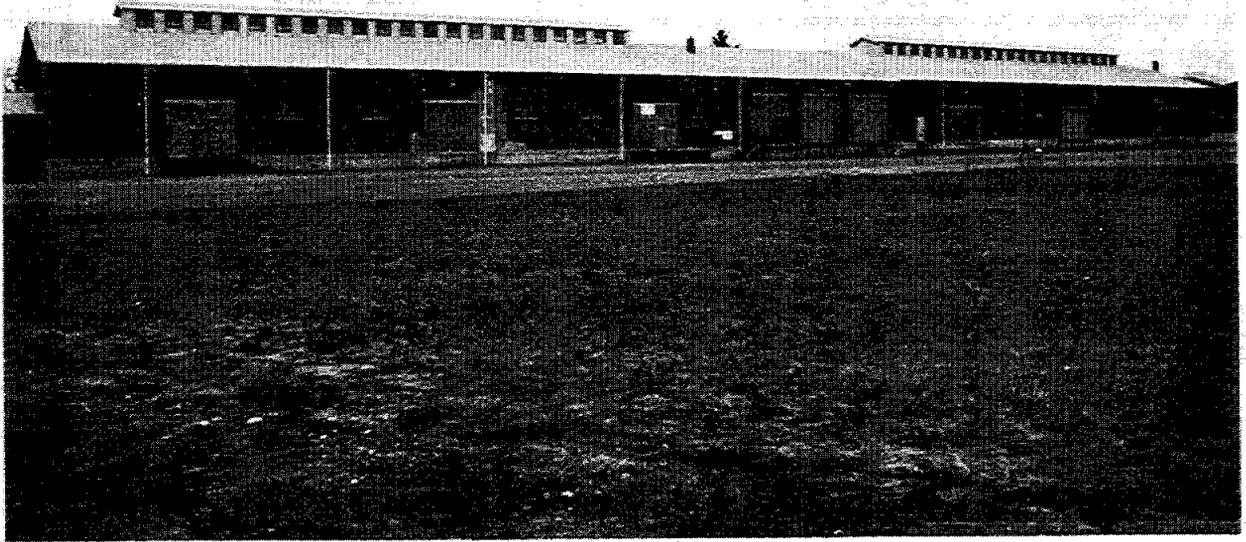
1987 PHOTO

1. Repointing needed, particularly at pilasters, south, north, west sides. A previous repoint job on south side has all but completely covered the face of the red clay units with a coating of mortar. Appears to have just "painted over" the old mortar with new.
2. Infill freight doors (T 1-11 or plywood) inappropriate design choice. Out of character.
3. Windows: Some chipped paint is leading to sash rusting. Numerous broken panes of glass.
4. Downspout on west end addition is coming apart.
5. Some cast iron foundation vent grilles are missing.
6. South side: Pilaster corners are broken off, probably from trucks.
7. Mortar at window heads on east side deteriorated.
8. Foundation at northeast corner: spalled concrete is exposing rebar.
9. North side at juncture of two buildings: Vertical stress crack, full height.

- a. Refer to article on "Brick Masonry Walls".
- b. Remove all deteriorated mortar and excess mortar on face of clay units.
- c. Clean joints thoroughly and repoint with new mortar tinted to match existing.
- d. Tool joints to match existing.

- a. Better solution may have been to design infill panels that replicated original door design.

- a. Refer to article on "Steel Windows".
- b. Remove all loose paint and rust by sanding, lightly grinding or sandblasting.
- c. Replace broken panes.
- d. Prime and repaint.

- a. Reattach lower end of downspout with copper pop-rivets.
- b. Solder joint.

- a. Replace with grilles matching existing at other locations. Missing grilles may have just dropped into the crawl space.

- a. Replace damaged clay units with new or salvaged units matching original in size, color and texture.
- b. Provide steel angle corner protection at locations next to active loading docks.

- a. Refer to article on "Brick Masonry Walls" and repoint accordingly.

- a. Refer to article on "Concrete".
- b. Chip out concrete all around rebar. Undercut edges.
- c. Clean all rust off steel.
- d. Treat with bonding agent.
- e. Patch with new concrete.

- a. Consult a preservation structural engineer for analysis and repair procedure.
