## BUILDING 4174

**BUILDING 4174**

## CONDITION SURVEY

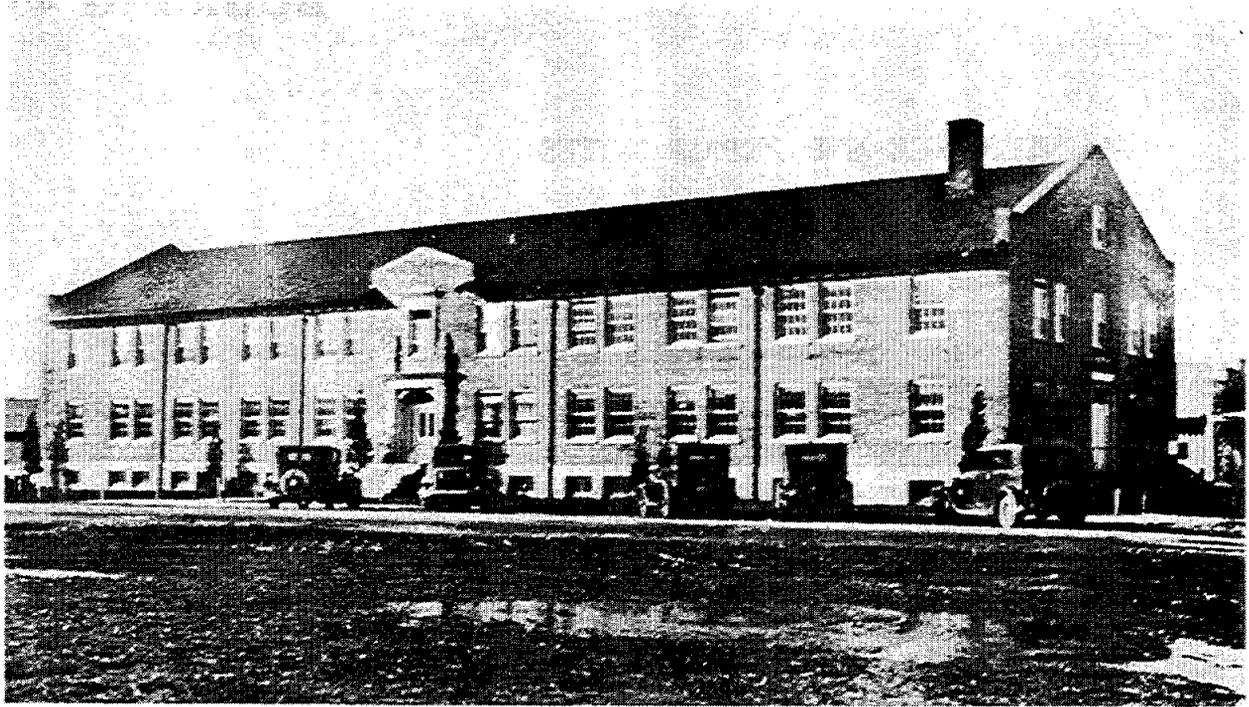
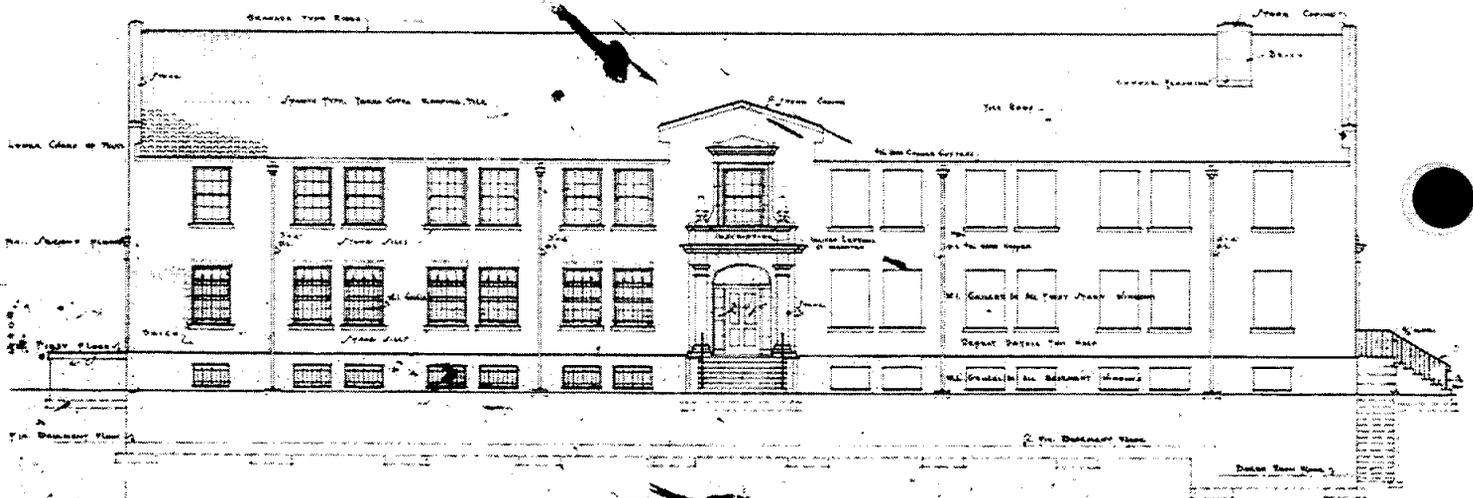
NINE BAYS SHOWN - ACTUALLY BUILT WITH ELEVEN BAYS

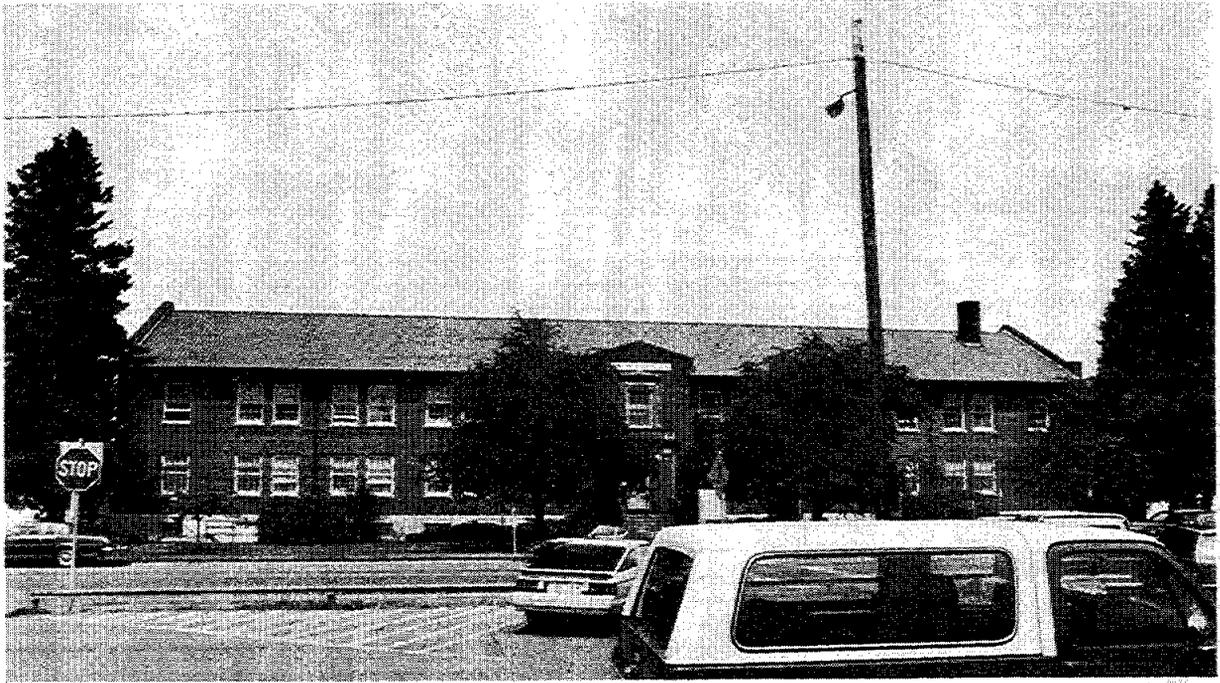
1987 PHOTO

1. Mortar deteriorated up near parapet. Moss and dirt on walls. Stone copings need new joint mortar.
2. East end entry: Original doors have been replaced and the transom removed. The porch and walkway roof addition is very awkward and covers/obscures the stone trimwork and pediment around entry.

3. Walls: Mortar deterioration beneath fire escape supports. Very poor brick infill patch on south side - wrong brick type and sloppy joint work. Face deterioration and heavy soiling on stone work around main entry (spalling, wear, graffiti).

4. Windows: Moss growth on stone sills. Severe paint deterioration on wood windows. Putty completely gone some places. Aluminum replacement window on west end is out of character.

5. Sign support poles would be more compatible if painted black.
6. Birds are nesting where closure boards between rafter tails have fallen out on north side.

7. Copper fascia around west service door canopy is damaged.
8. Metal fire escapes: much rusting and paint peeling, particularly on treads and rail.

- a. Refer to article on "Brick Masonry Walls".
- b. Clean masonry of all moss and dirt accumulation.
- c. Repoint where mortar is deteriorated in area of parapets.
- d. Repoint mortar joints of stone copings with new mortar tinted to match existing.

- a. Remove canopy over walkway and steps.
- b. Restore door and transom to original configuration.
- c. If a roof over the entry is necessary one could be designed that is much more suitable to the building.

- a. Obtain services of experience masonry/stone restoration firm to clean decorative stone work around entry.
- b. Thoroughly clean out bad mortar and repoint below fire escapes. New mortar should be tinted to match existing adjacent.

- a. Clean moss off stone sills with stiff natural bristle brush.
- b. Refer to "Wood Window" article for procedures to recondition wood windows.
- c. Replace aluminum window with appropriate style steel sash window.

- a. Paint black.

- a. Replace boards.

- a. Straighten bent areas.
- b. Patch small torn area.
- c. Resolder joints.

- a. Remove all rust by sanding, lightly grinding, or sandblasting.
- b. Replace severely rusted elements.
- c. Wire brush all loose paint.
- d. Prime and paint.
