## BUILDING 4175

# BUILDING 4175

## CONDITION SURVEY

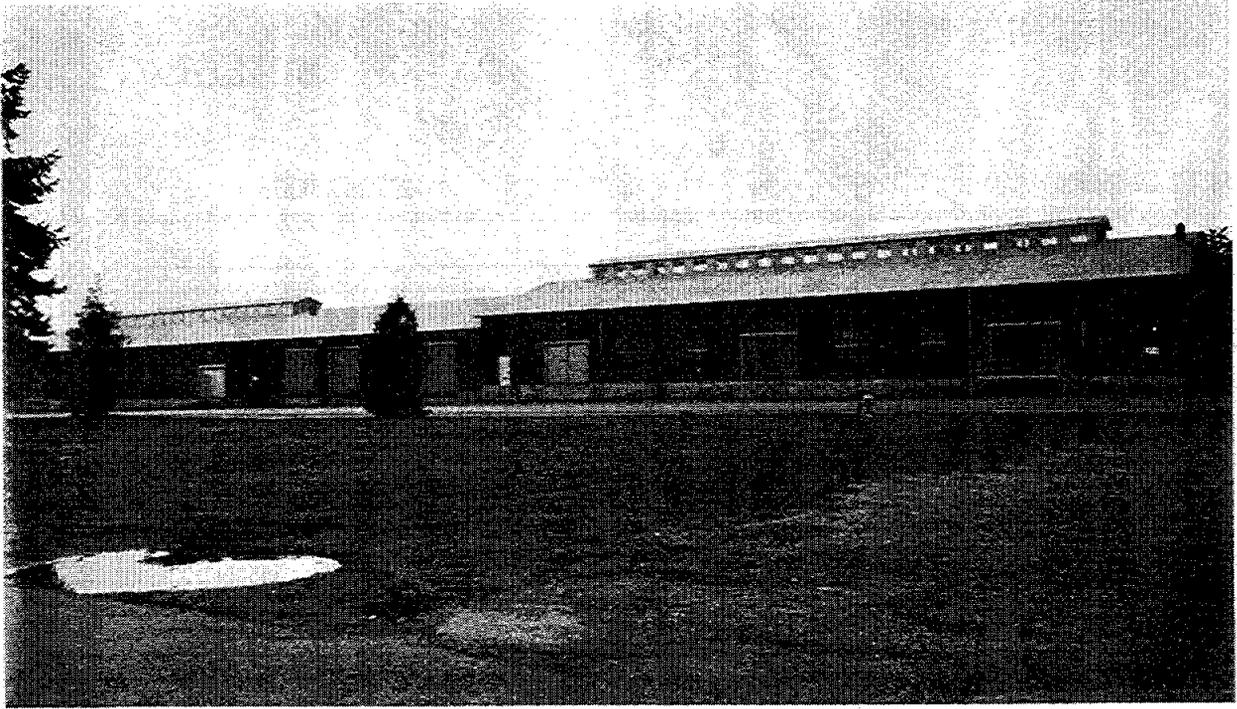
1987 PHOTO

1. **Foundation:** Serious crack and overstressing at southeast corner, southwest corner, northwest corner.
2. **Walls:** 45° crack through mortar joints from foundation to halfway up wall (south side near east end, and north side near west end.) Mortar very soft and crumbly. Repointing needed (south, west, and north sides). Stress cracks down joints where low bay meets high bay, and other locations on south and north walls.
3. Filled in freight doorways - intrusive design.
4. **East end:** Appears that a window (or possibly door) was filled in and a new double flush wood door cut in. Mortar needs repointing this area.
5. Many broken window panes. Chipped paint and rust on steel sash.

- a. Consult preservation structural engineer for proper repair procedure.

- a. Repoint south, north, and west sides.
- b. Consult structural engineer for analysis and repair of vertical and diagonal stress cracks.

- a. Better solution may have been to design infill panels that replicated original door design.

- a. Thoroughly clean deteriorated mortar out of joints.
- b. Replace with new mortar tinted to match existing adjacent.
- c. Tool joints to match existing.

- a. Refer to article on "Steel Windows".
- b. Remove all rust by sanding, lightly grinding, or sand blasting.
- c. Scrape and sand other areas of loose paint.
- d. Replace broken panes.
- e. Prime and repaint sash.
