## BUILDING 4274

# CONDITION SURVEY DATA SHEET

**CONDITION SURVEY**

**RED CROSS HOSTESS HOUSE**

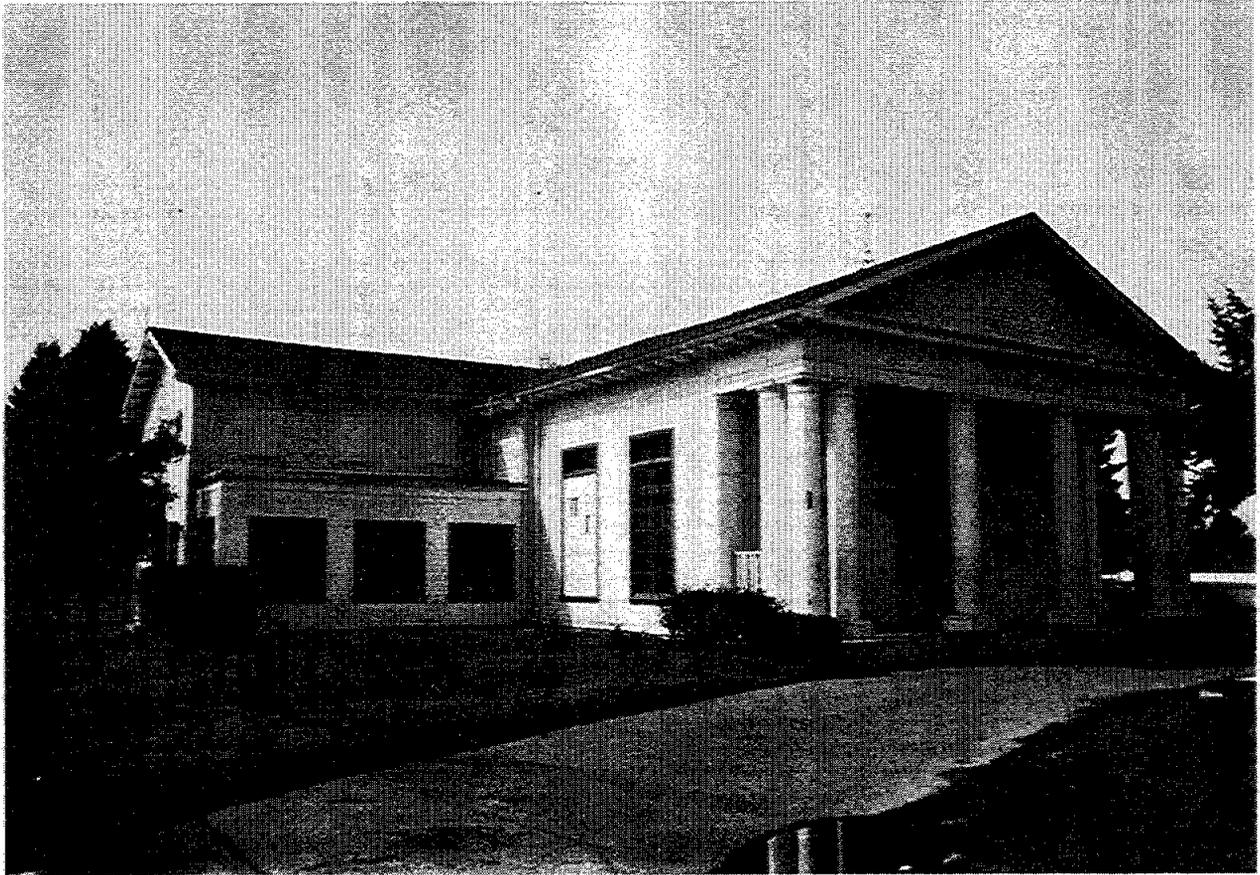
1987 PHOTO

The Hostess House has a concrete pier foundation and is one of the few historic wood frame buildings remaining at Fort Lewis. It has suffered severe neglect resulting in water damage to interior finishes and window sashes.
