BUILDING 2050

CONDITION SURVEY

SHOP

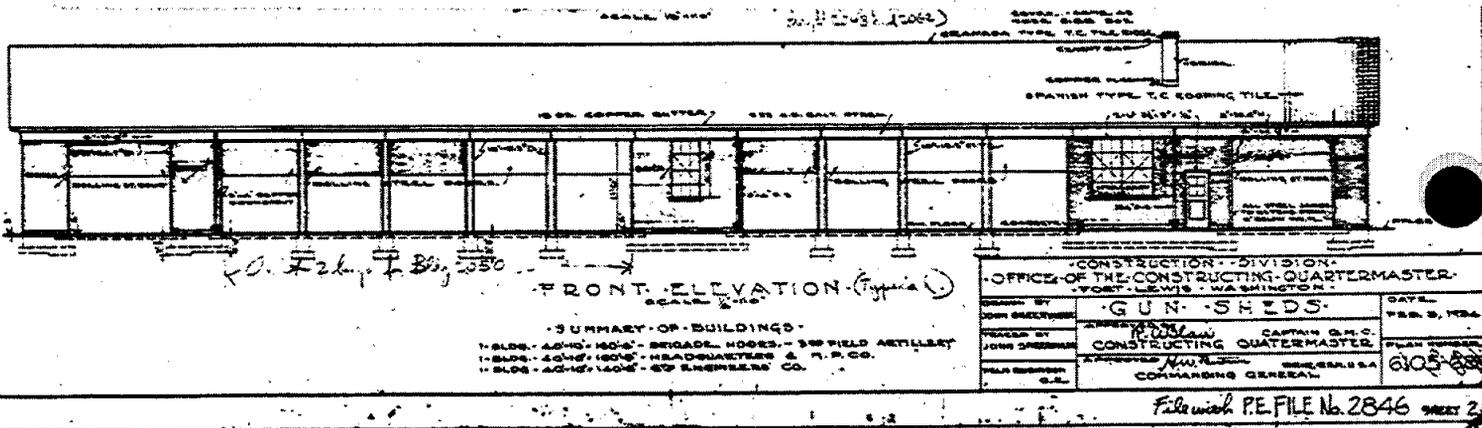
BUILDING 2050

1. Birds are entering soffit.
2. T 1-11 infill panels are not appropriate to character of building.
3. Aluminum sliding windows are not appropriate to character of building.
4. Metal sashes are rusting.
5. Caulk at sashes is hardening.
6. Moss is present on window sills.
7. Pounded water is present at man doors.
8. Masonry is soiled with mud at north side.
9. Site does not drain well.
10. Tile is missing at east gable end.
11. Shed roof leaks, rafter ends are splitting and weak, decking is rotting, gravel stop is loose, birds are nesting at column bracing and at junction with building.

1. **BIRDS**
 - a. Close or screen openings.
 - b. Remove bird droppings from face of building.
2. **T 1-11 PANELS**
 - a. As budget permits, replace with horizontal siding characteristic of the period.

- b. Since plywood siding may not last as long as horizontal siding, its eventual replacement must be budgeted for.
3. **ALUMINUM WINDOWS**
 - a. Replace with wood sash windows.

4. **RUSTING SASHES**
 - a. Remove all rust with wire brush, sanding and steel wool.
 - b. Protect glass.
 - c. Prime immediately.
 - d. Replace loose, missing or cracked glazing putty.

- e. Paint with oil based semi-gloss paint.
 - f. Oil hardware.
5. **CAULK AT SASH**
 - a. Remove hardened, brittle caulk.
 - b. Replace with new resilient caulk all around.

8. **SOILED MASONRY**
 - a. Scrub with natural bristle brush and spray from garden hose.
 - b. Clean periodically to keep masonry free of material which holds moisture.

9. **SITE DRAINAGE**
 - a. Regrade to drain away from building and work areas.
10. **GABLE END TILE**
 - a. Replace with tile matching existing in appearance and quality.
