## NCO HOUSING TYPE 2 B

**BUILDINGS 5002, 5004, 5009, 5011, 5013**

# CONDITION SURVEY DATA SHEET

## CONDITION SURVEY

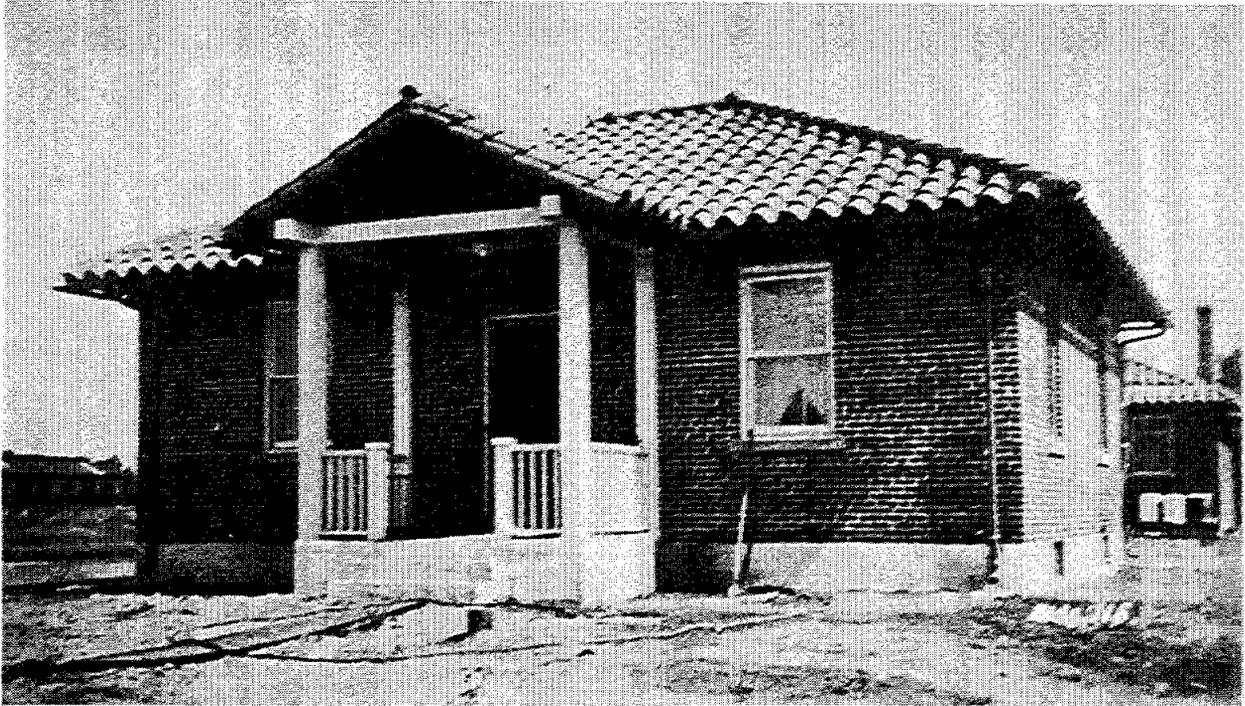
There are only five of these small bungalows at Fort Lewis. They were constructed in 1930 from standard Quarter Master General plans and were completely furnished with "Heavy N.C.O. New Pattern" furniture.

The residences have 756 square feet of living space and full basements. The walls are tile faced with brick and the roofs are "California Mission" tile.

The buildings are close to original design and are in good condition.
