OFFICER'S HOUSING TYPE 1A

CONDITION SURVEY DATA SHEET

OFFICER'S HOUSING TYPE 1 A

CONDITION SURVEY

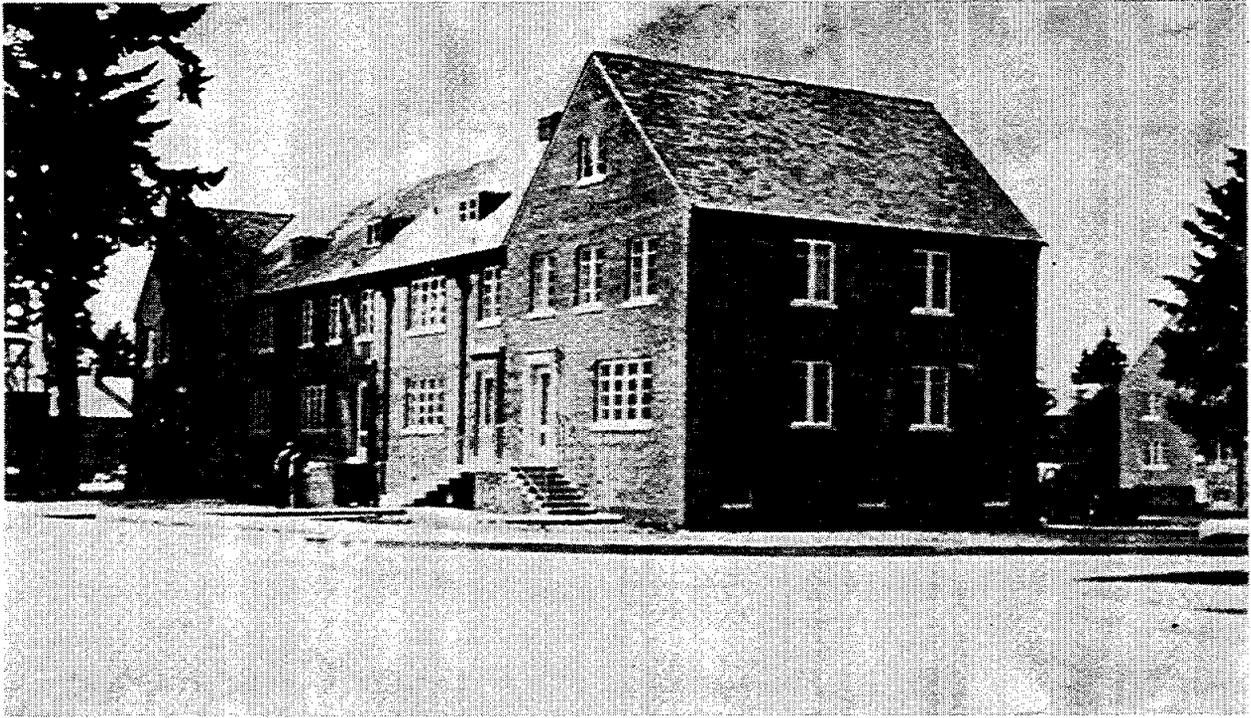
Six examples exist: 2660, 2662, 2665, 2667, 2668, and 2669.

These buildings were constructed in 1939 as Officers' Apartments, each to house five families. They are two-story brick tudor style on concrete foundation, walls are concrete with an exterior brick facing, and roof consists of intersecting gables with tile roofing. The original flat tiles have been replaced with a mission style roofing tile. All examples remain intact and relatively unchanged from their original state.
