OFFICER'S HOUSING TYPE 1-C

CONDITION SURVEY DATA SHEET

CONDITION SURVEY

FOUR FAMILY APARTMENTS

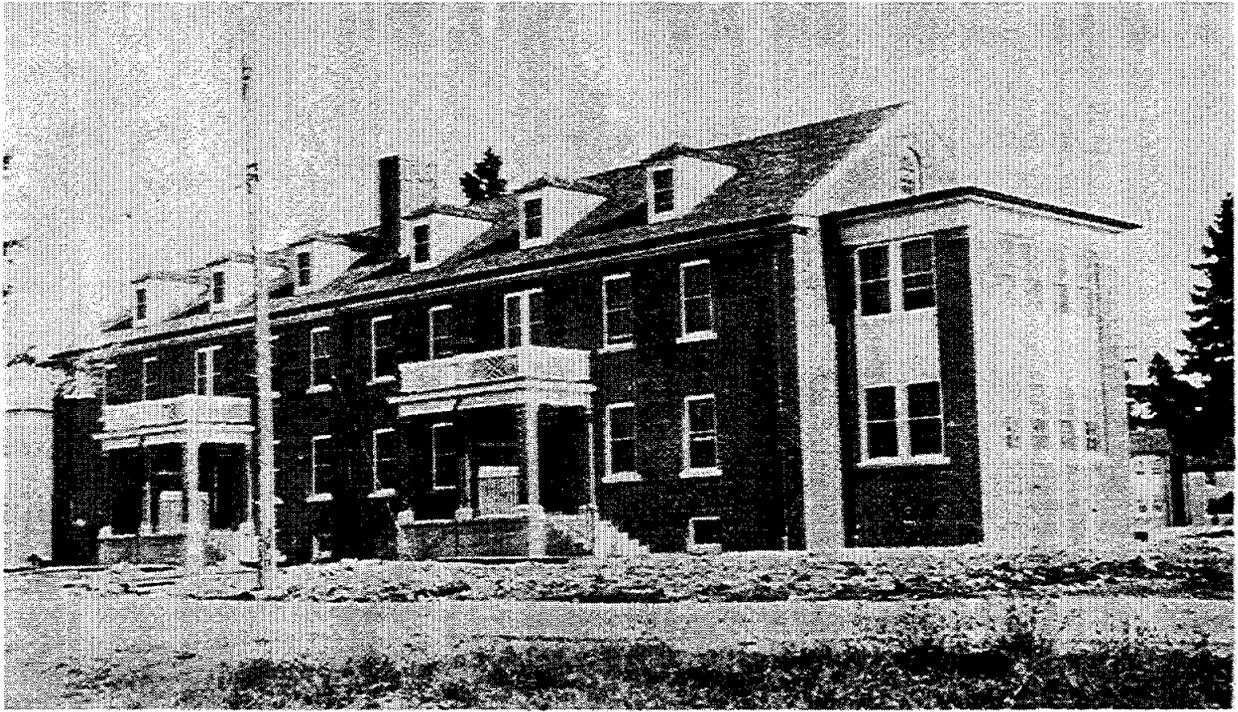
1. Downspouts terminate 12" or more above grade with no splash blocks.
2. Dormer sidewalls siding is deteriorating and flashings may be inadequate.
3. General paint failure at all painted items (windows, trim, porch roofs, dormers).

- a. Check adequacy of sidewall flashings.
- b. Replace deteriorated siding pieces.
- c. Scrape, sand and fill areas with loose paint.
- d. Repaint dormers.

- a. Refer to article on "Wood".
- b. Scrape, sand, and fill areas of failed paint.
- c. Treat bare wood with paintable water repellent preservative. Repaint with one prime and two finish coats.
