## BUILDING 4175

# BUILDING 4175

## CONDITION SURVEY

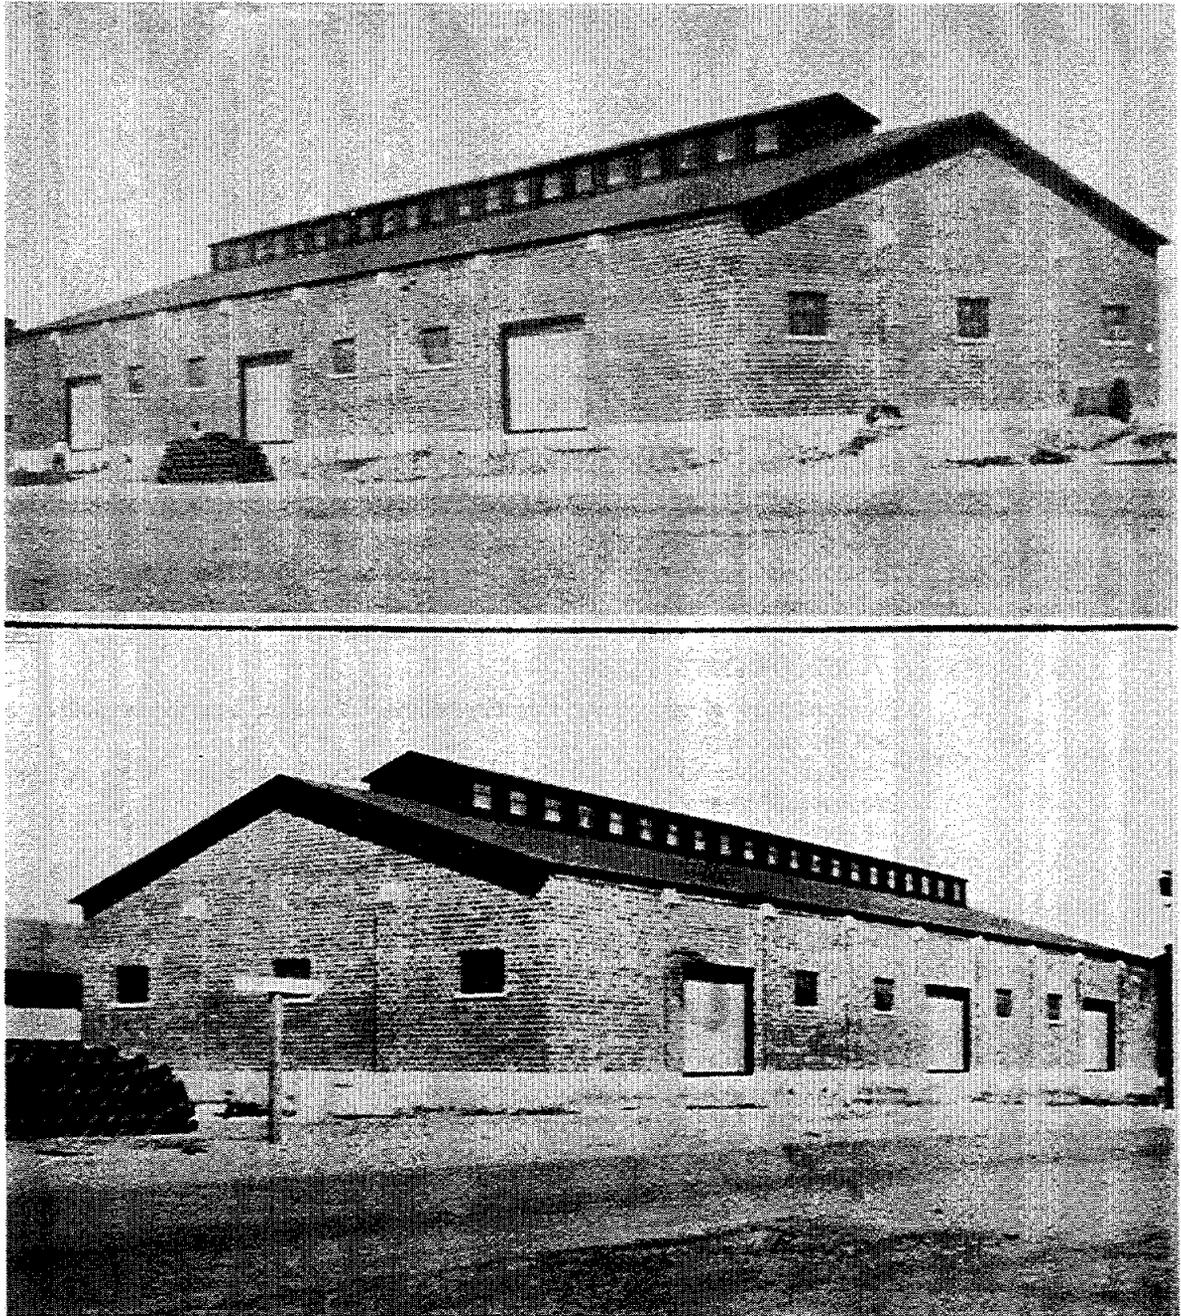
1. **Foundation:** Serious crack and overstressing at southeast corner, southwest corner, northwest corner.
2. **Walls:** 45° crack through mortar joints from foundation to halfway up wall (south side near east end, and north side near west end.) Mortar very soft and crumbly. Repointing needed (south, west, and north sides). Stress cracks down joints where low bay meets high bay, and other locations on south and north walls.
3. Filled in freight doorways - intrusive design.
4. **East end:** Appears that a window (or possibly door) was filled in and a new double flush wood door cut in. Mortar needs repointing this area.
5. Many broken window panes. Chipped paint and rust on steel sash.

- a. Consult preservation structural engineer for proper repair procedure.

- a. Repoint south, north, and west sides.
- b. Consult structural engineer for analysis and repair of vertical and diagonal stress cracks.

- a. Better solution may have been to design infill panels that replicated original door design.

- a. Thoroughly clean deteriorated mortar out of joints.
- b. Replace with new mortar tinted to match existing adjacent.
- c. Tool joints to match existing.

- a. Refer to article on "Steel Windows".
- b. Remove all rust by sanding, lightly grinding, or sand blasting.
- c. Scrape and sand other areas of loose paint.
- d. Replace broken panes.
- e. Prime and repaint sash.
