## BUILDING 4274

# CONDITION SURVEY DATA SHEET

**CONDITION SURVEY**

**RED CROSS HOSTESS HOUSE**

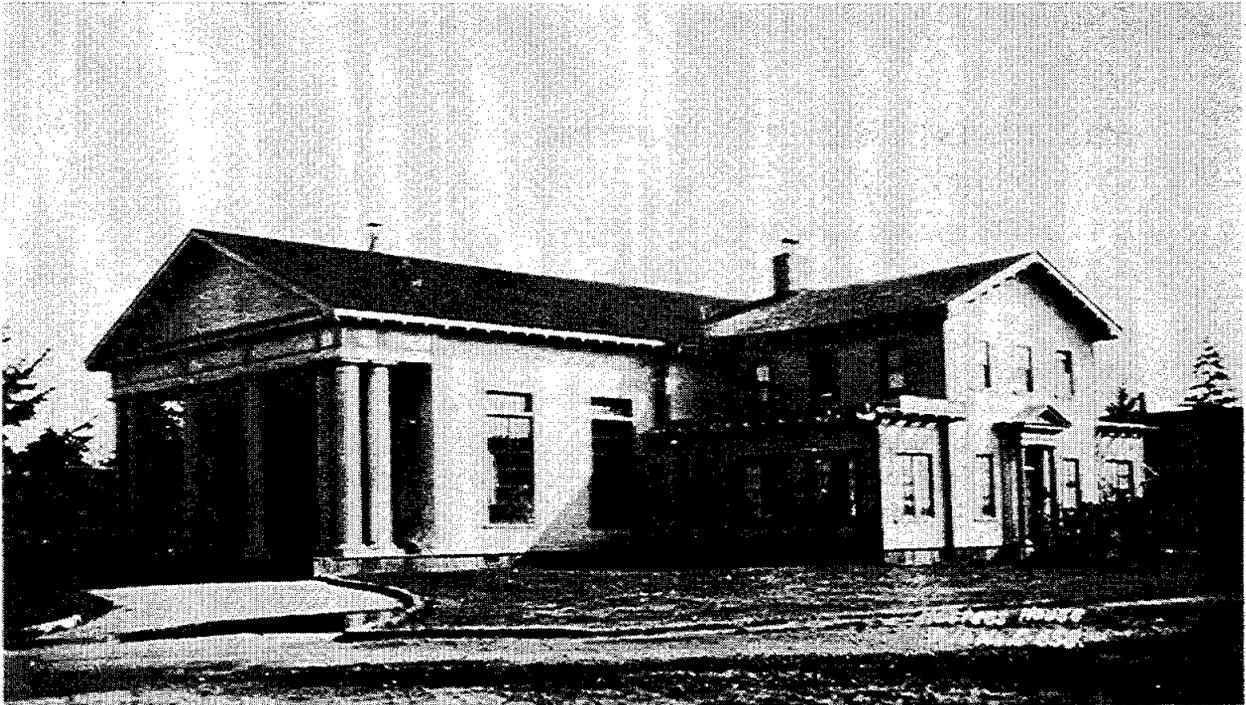
Building 4274 was constructed in 1918 by the Red Cross as the Hostess House. It is one of the 13 surviving buildings of Camp Lewis. It originally contained a 500 seat auditorium, kitchen, offices, lounge, library and room for six beds.

The Hostess House is designed in the symmetrical form of a cross and is characterized by its Greek revival facade and double height multi panel windows. It is situated north of the center of the post with its primary facade now facing Interstate 5.

The Hostess House has a concrete pier foundation and is one of the few historic wood frame buildings remaining at Fort Lewis. It has suffered severe neglect resulting in water damage to interior finishes and window sashes.

It is currently used for a youth center, with most of the original millwork and trim either removed or covered up.
