## BUILDING 4320

# CONDITION SURVEY DATA SHEET

BUILDING 4320

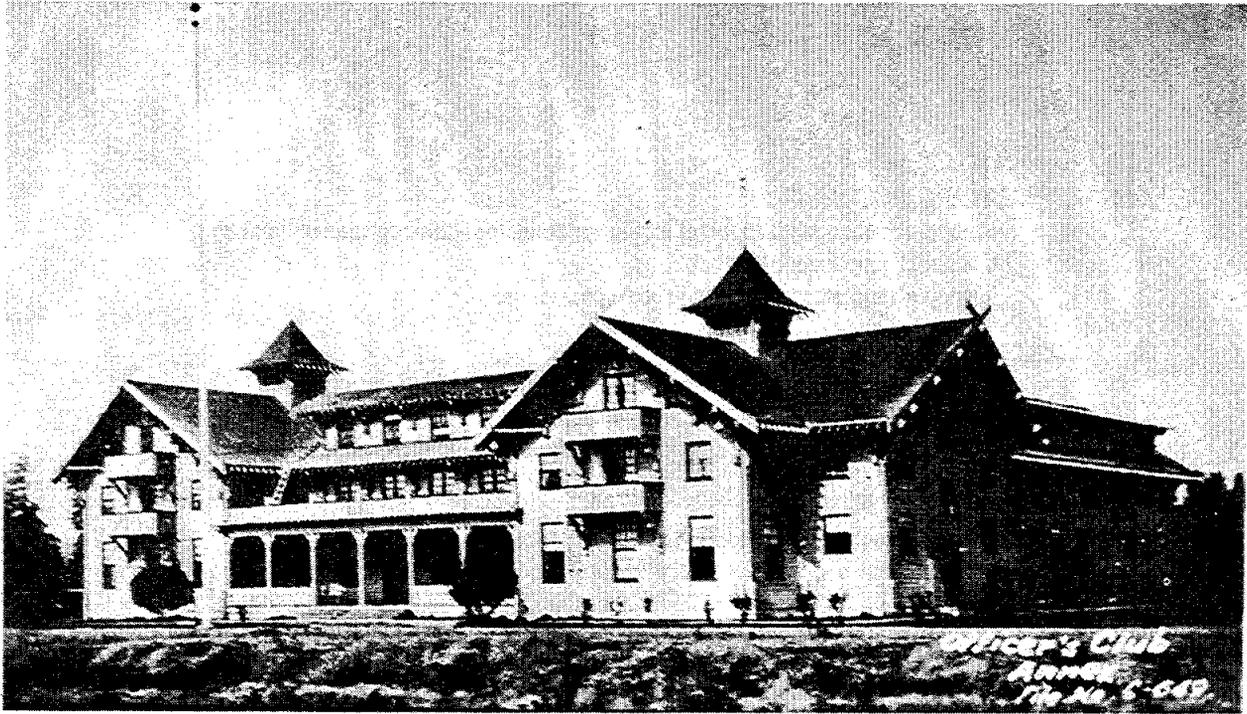
Built in 1919 by the Salvation Army as the Red Shield Inn, building 4320 (formerly 32) served as a hotel for visiting relatives and friends. It has been used as an officers club and currently is the post museum.

The wood-frame two-and-one-half story building is an eclectic rustic chalet style with extensive decorative cut-out railings and details. Multiple gabled units with deep overhanging eaves and brackets surround a central courtyard. The roofline is punctuated by two prominent cupolas. At its completion it was referred to as luxuriously furnished and the most imposing structure erected by the Salvation Army.

The Red Shield Inn is the only surviving building from Greene Park, the amusement area built adjacent to Camp Lewis.

The building is one of the most significant structures within the Fort Lewis complex, but has been sadly neglected. Asbestos cement shingles cover the original wood siding, and details such as balconies and crossed barge boards have been removed. Although the first floor has been modified to accommodate the museum, it retains much of the original detail and ornament including brick fireplace and lattice paneling. The second floor has been modernized with drop ceilings and partition walls that violate the architectural character, and the third floor, while essentially original fabric, has been seriously damaged by neglect, roof leaks, and insensitive installation of fire/smoke blocks.

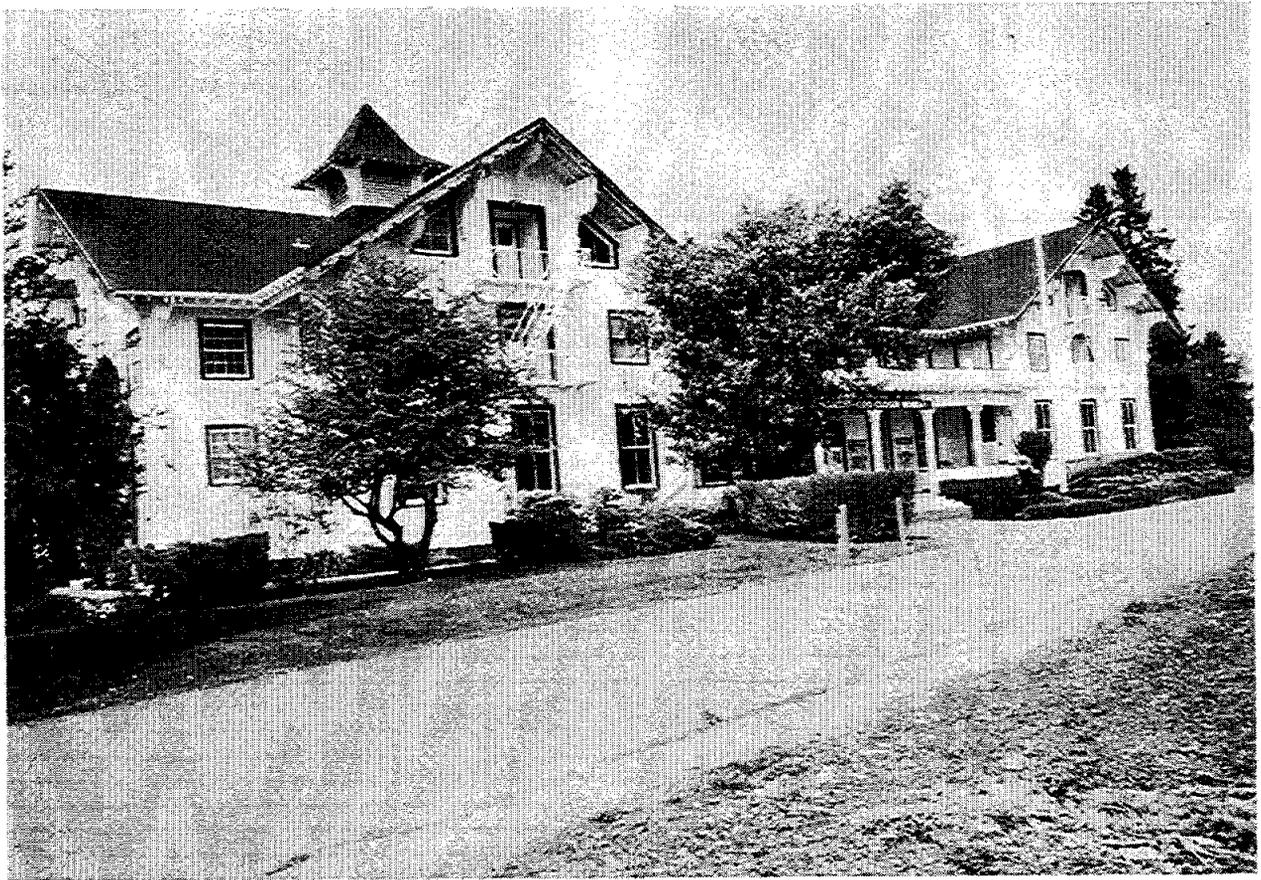
1987 PHOTO

**BUILDING 4320**
